AFWAL-TM-79-10

**TEST REPORT ON INFRARED
WARNING RECEIVER (IRWR) FLIGHT
VIBRATION MEASUREMENTS**

APRIL 1980

This test report presents data which define the vibration environments experienced by two infrared warning receiver (IRWR) units mounted on the HH-53 helicopter and the C-130E transport aircraft.

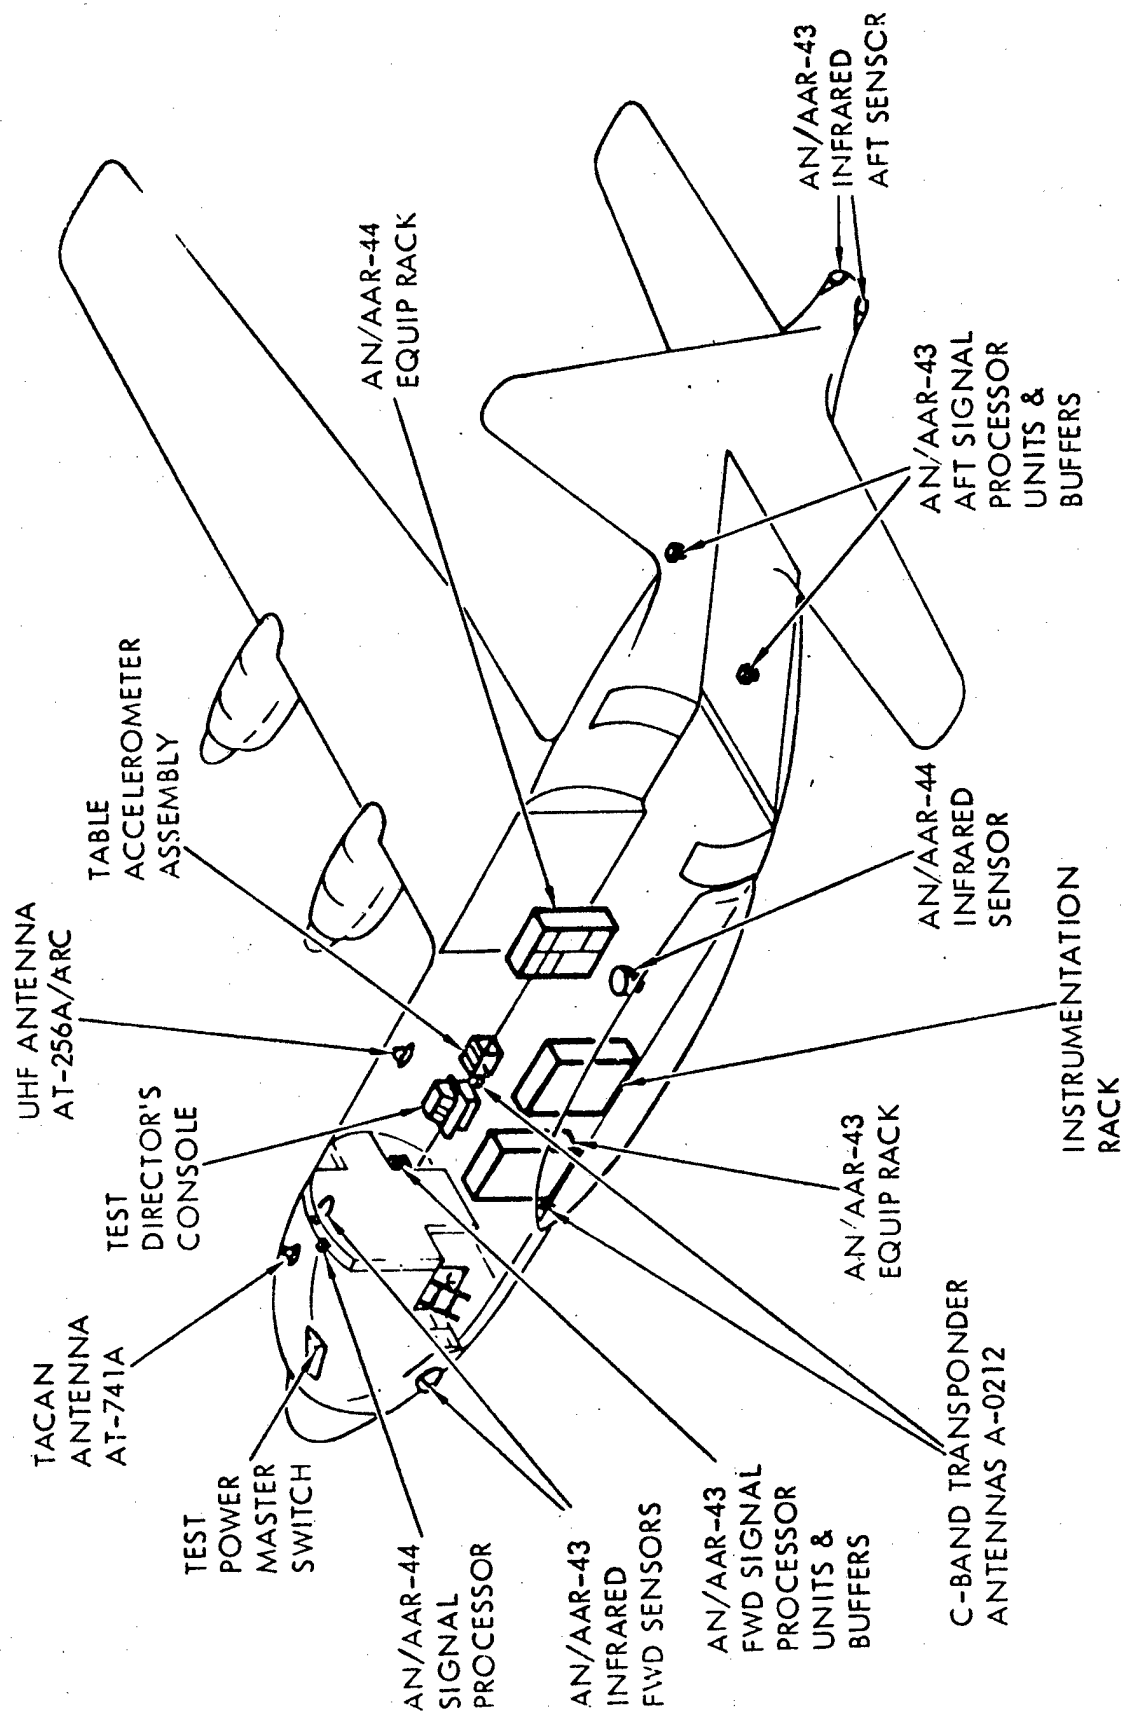
Figure 1. C-130E Installation.

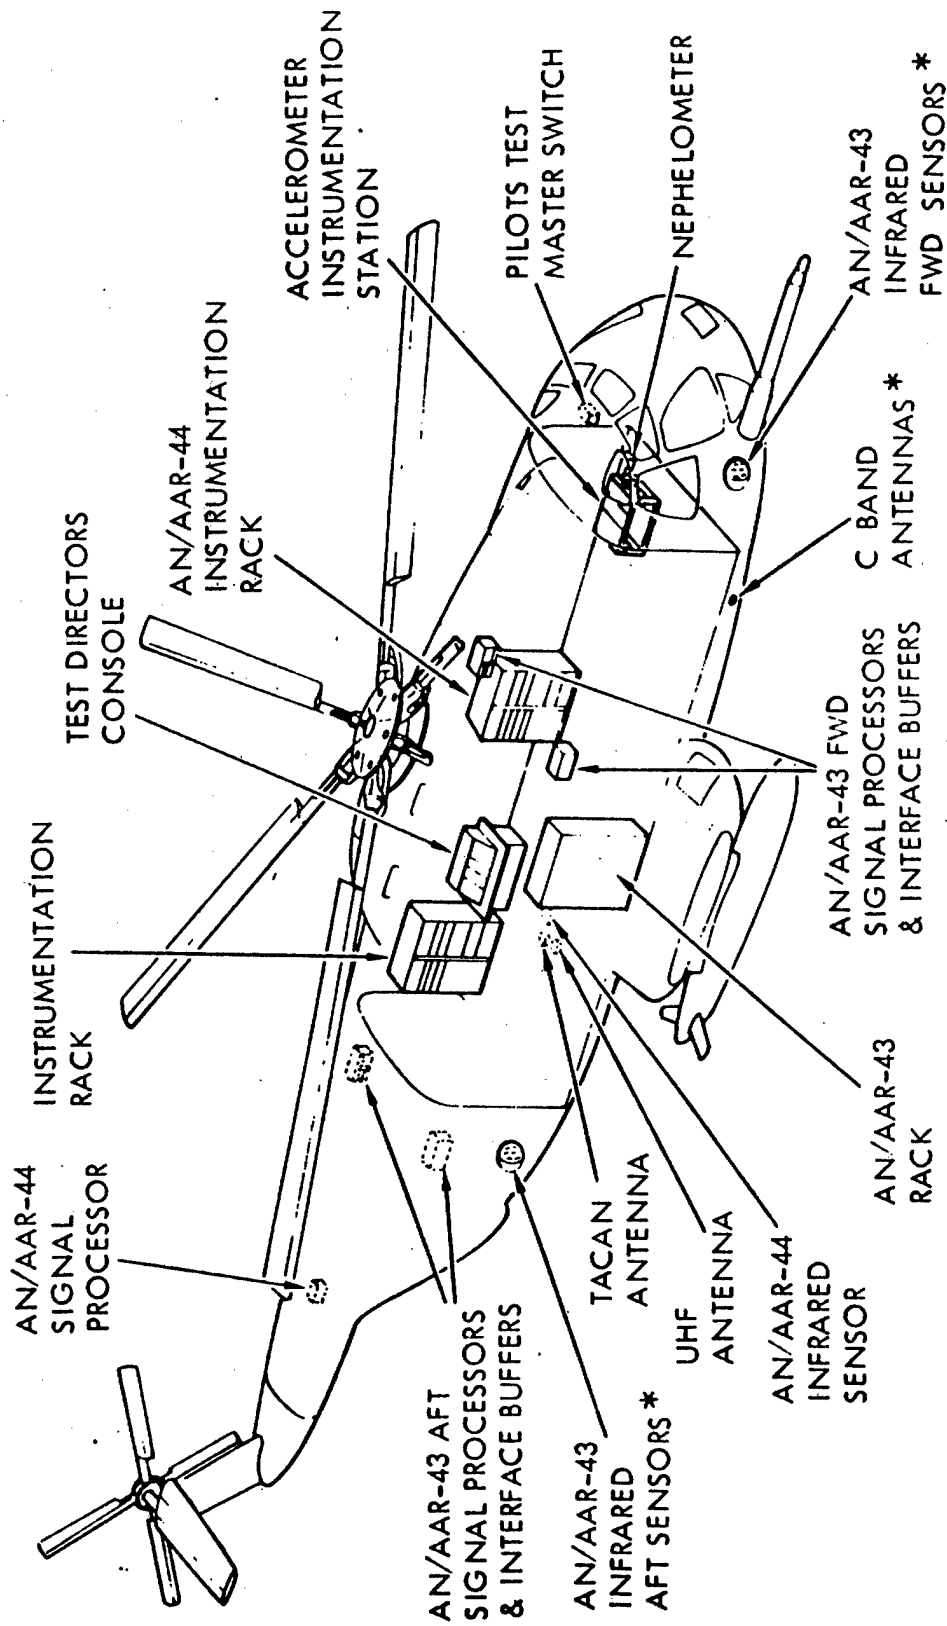
Figure 2. HH-53C Installation.

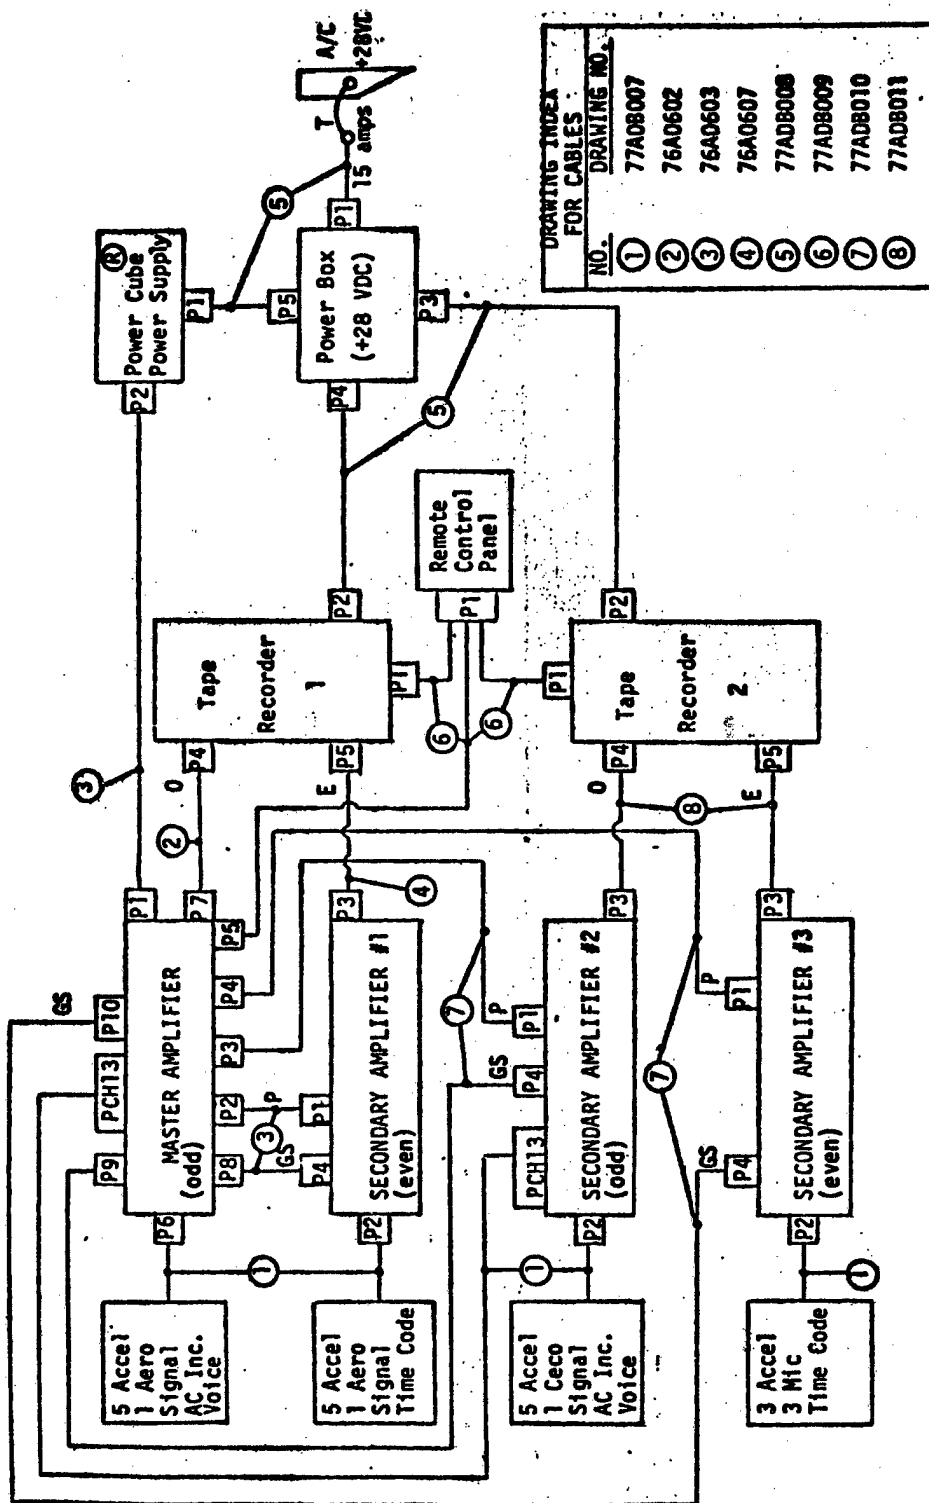
Figure 3. Vibration Instrumentation Block Diagram.

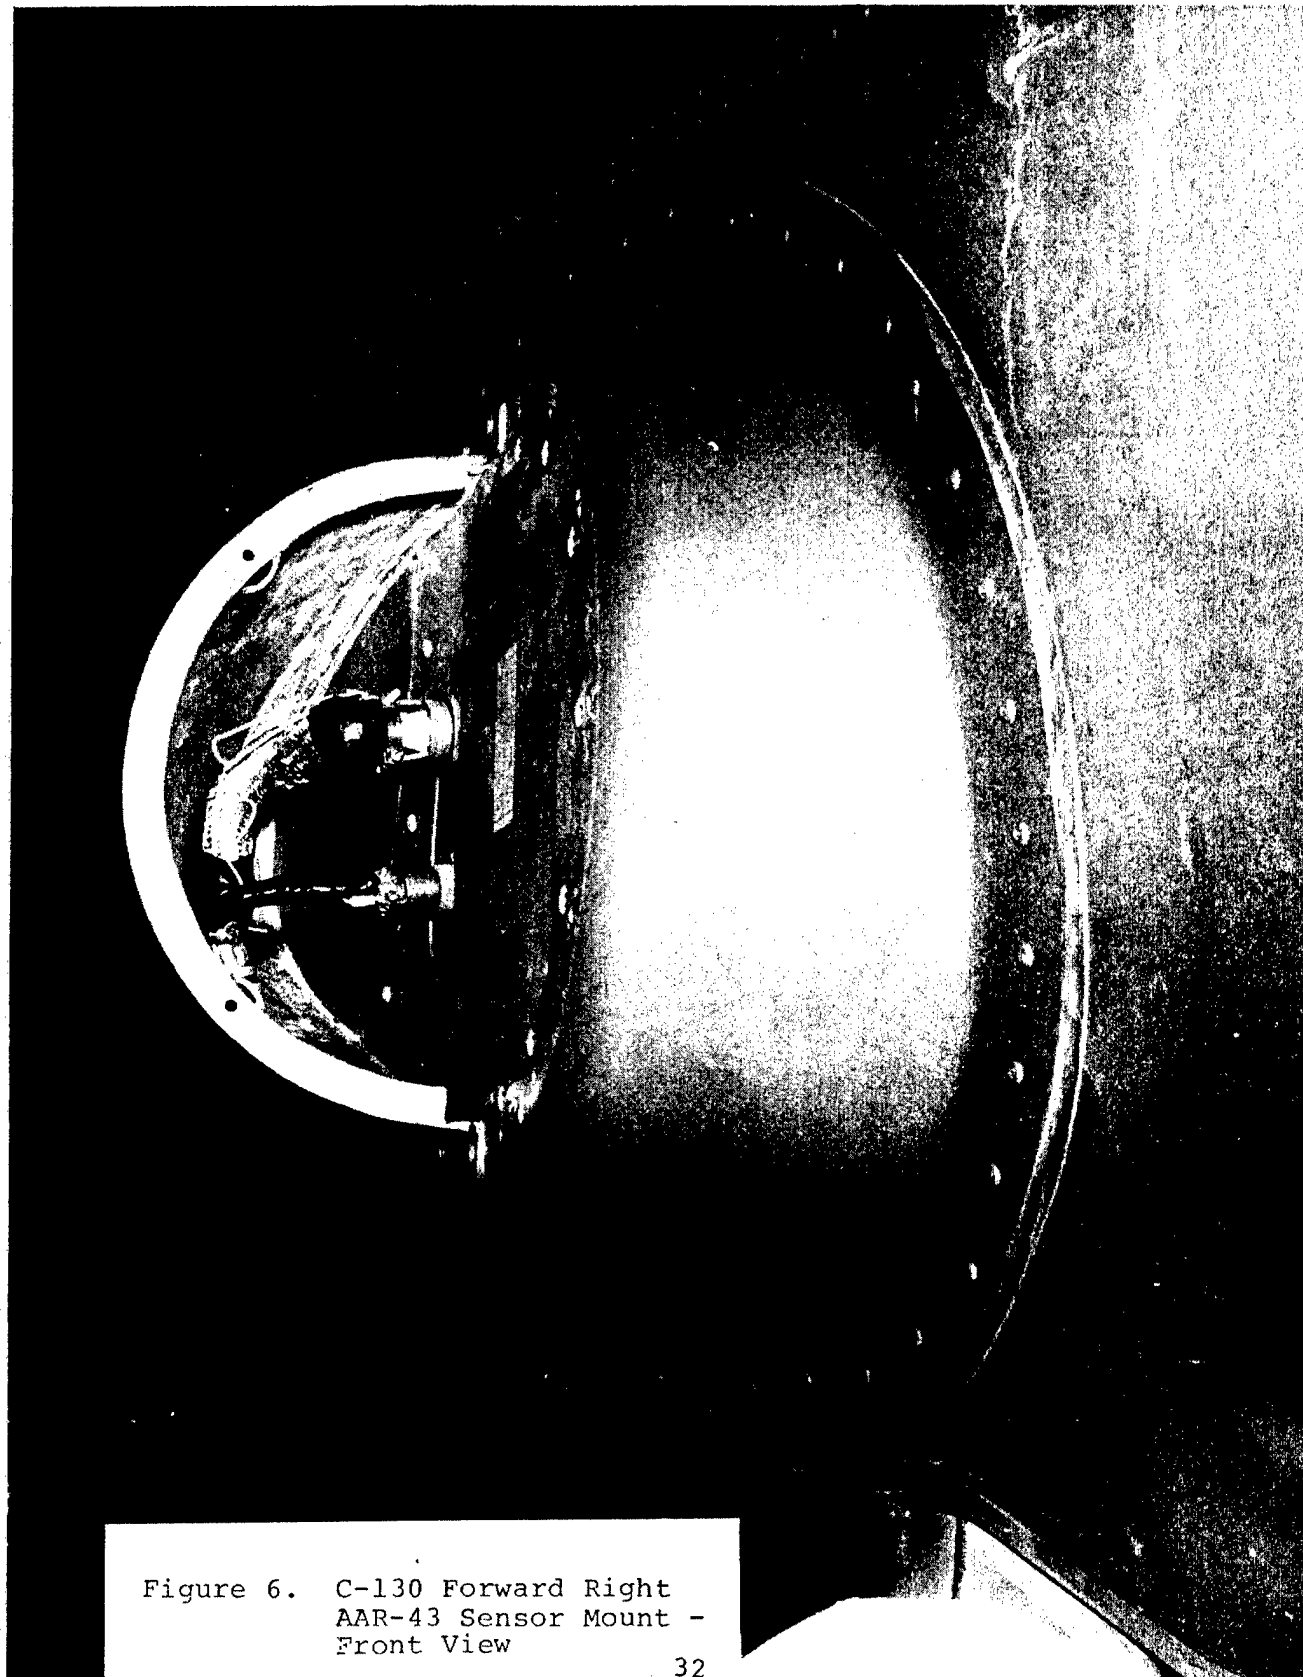
Figure 6. C-130 Forward Right
AAR-43 Sensor Mount -
Front View

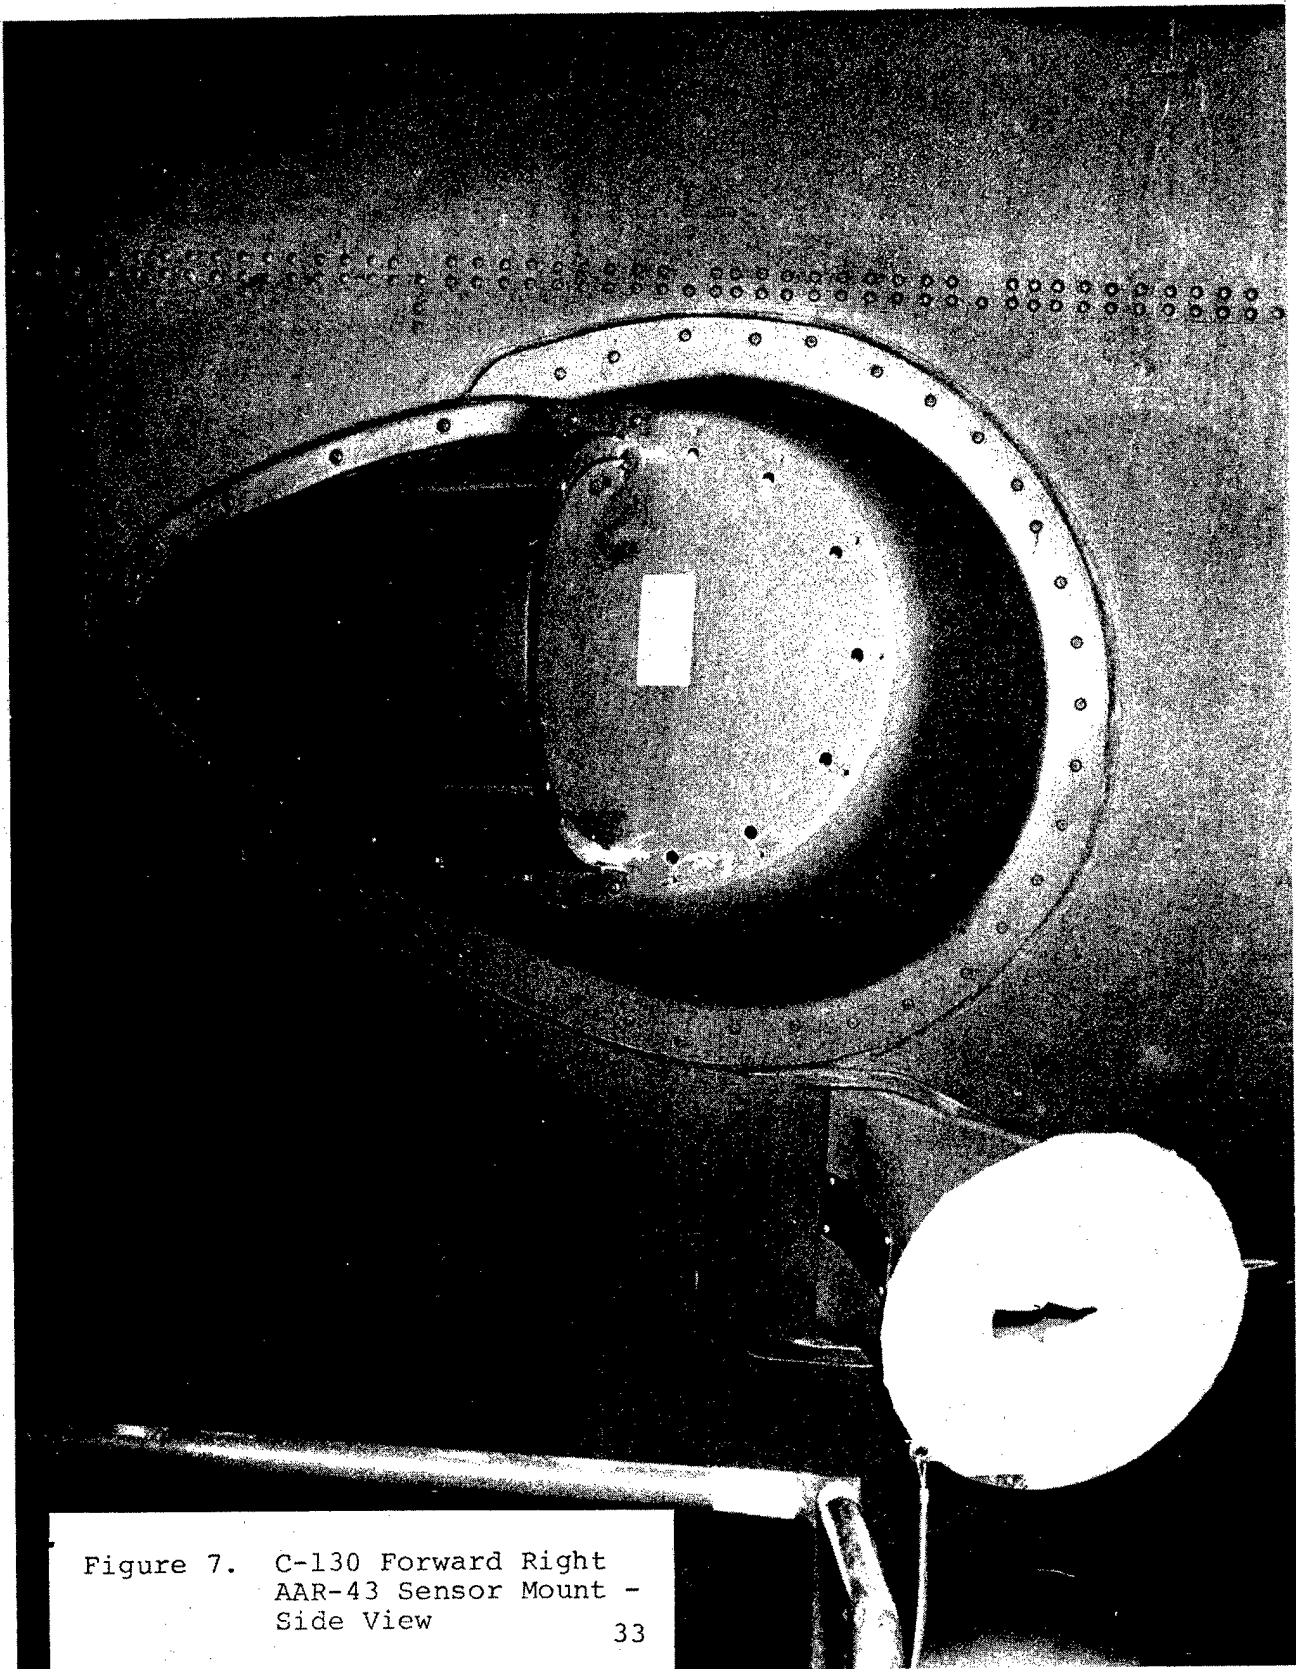
Figure 7. C-130 Forward Right
AAR-43 Sensor Mount -
Side View

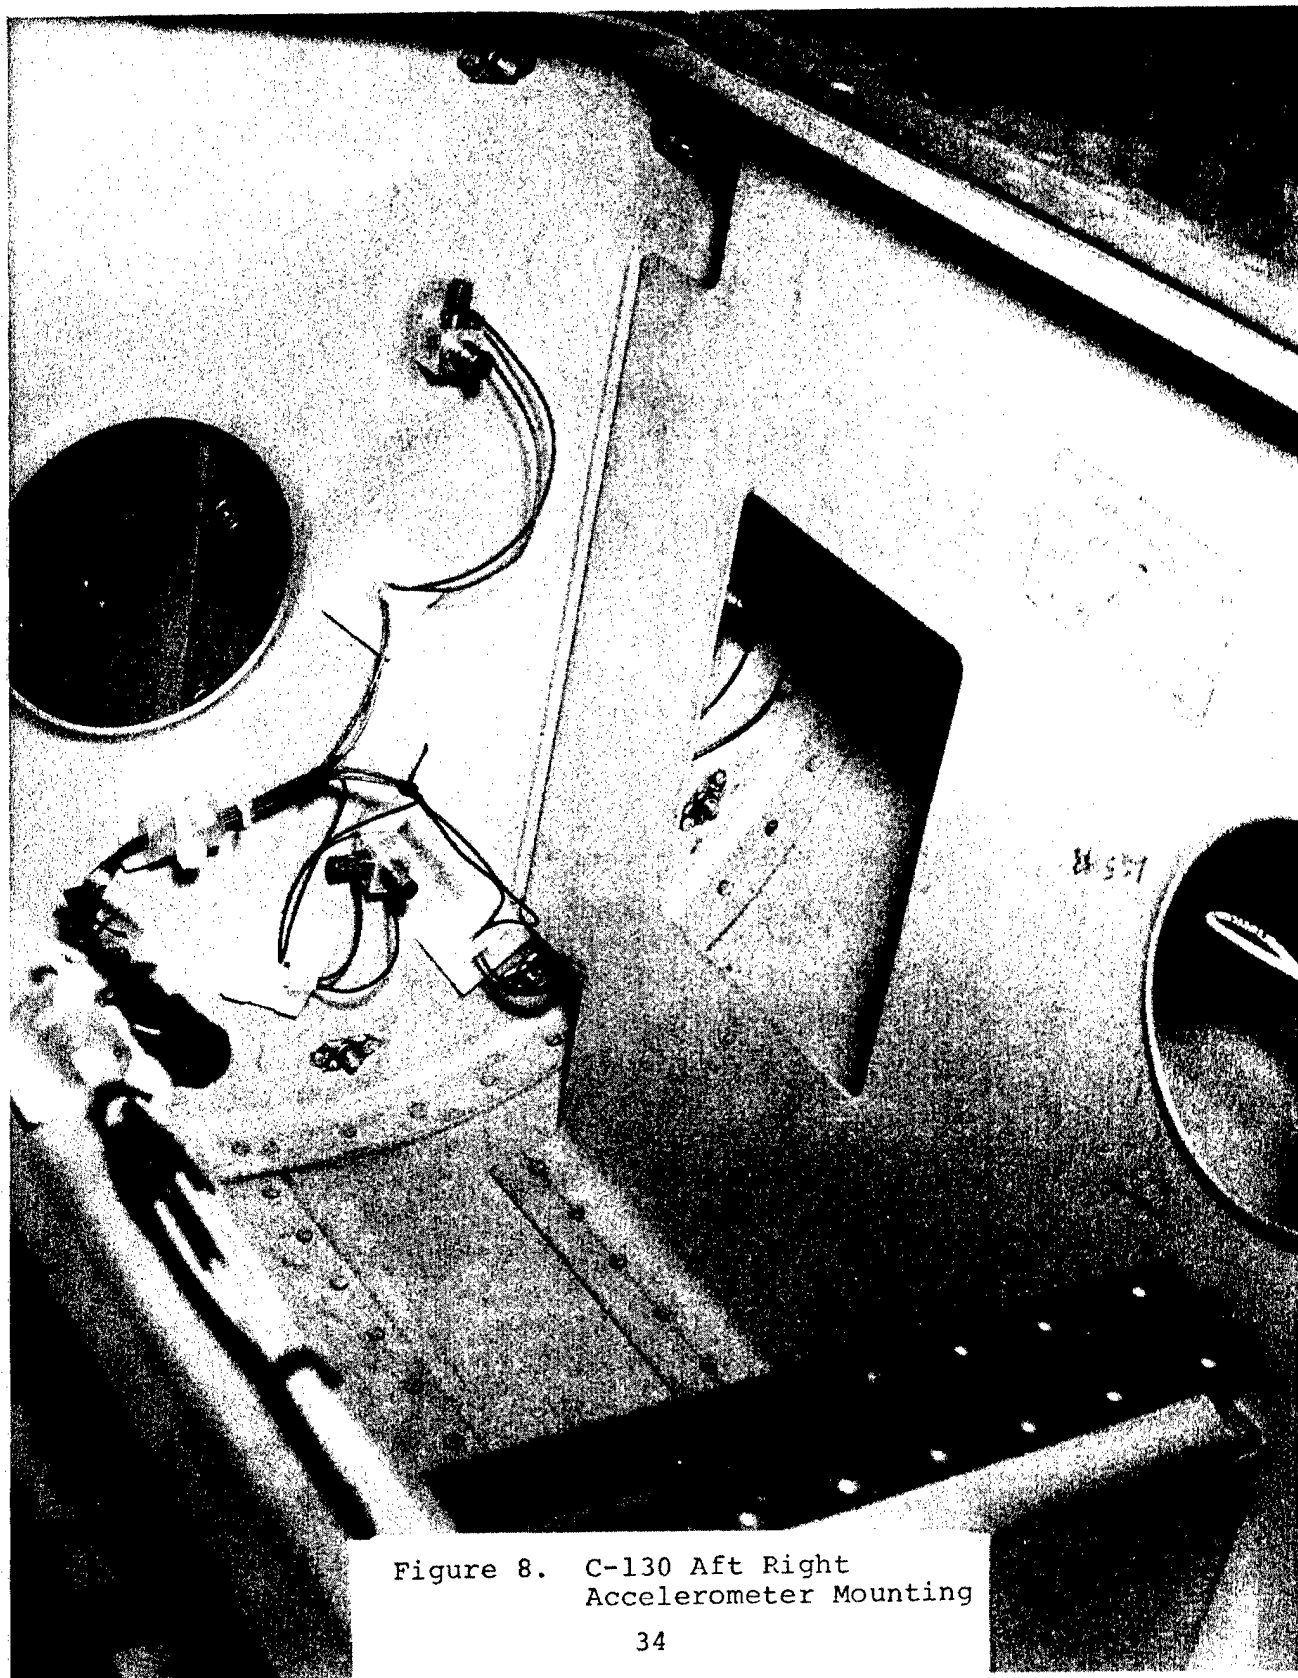
Figure 8. C-130 Aft Right
Accelerometer Mounting

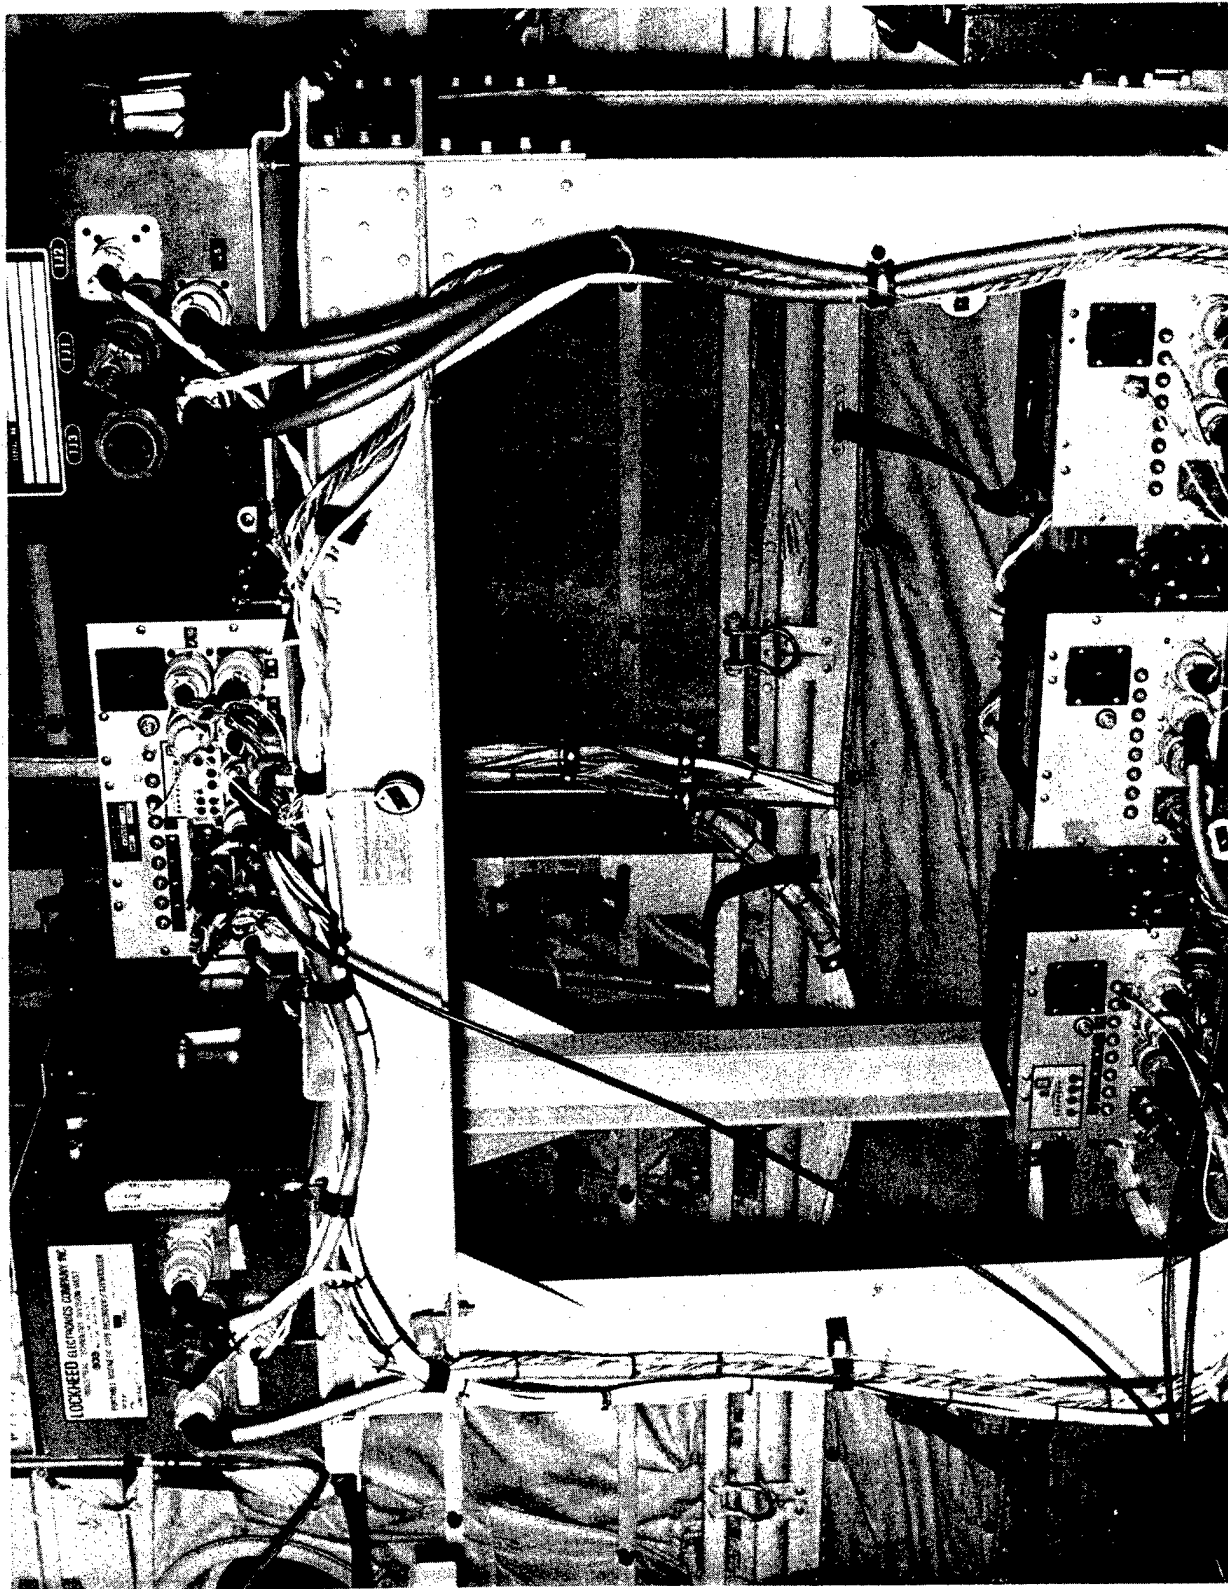
Figure 9. Wheaton Table and Electronics

The four amplifier systems, two tape recorders, power supplies, and power distribution box were mounted on a Wheaton table by 4950th TW personnel as shown in Figure 9. The table, including equipment and cables on it, was moved from one aircraft to the other as required by the test conditions. A separate remote control panel and its associated cables were installed in both aircraft, as shown in Figure 10. The four amplifier input signal cables and the aircraft power input cable were also installed in both aircraft. Thus, moving the instrumentation system on the Wheaton table required disconnecting and reconnecting the four amplifier input connectors, four remote control connectors, and the aircraft power input connector. The estimated weight of the Wheaton table plus equipment and cables was 196 pounds.

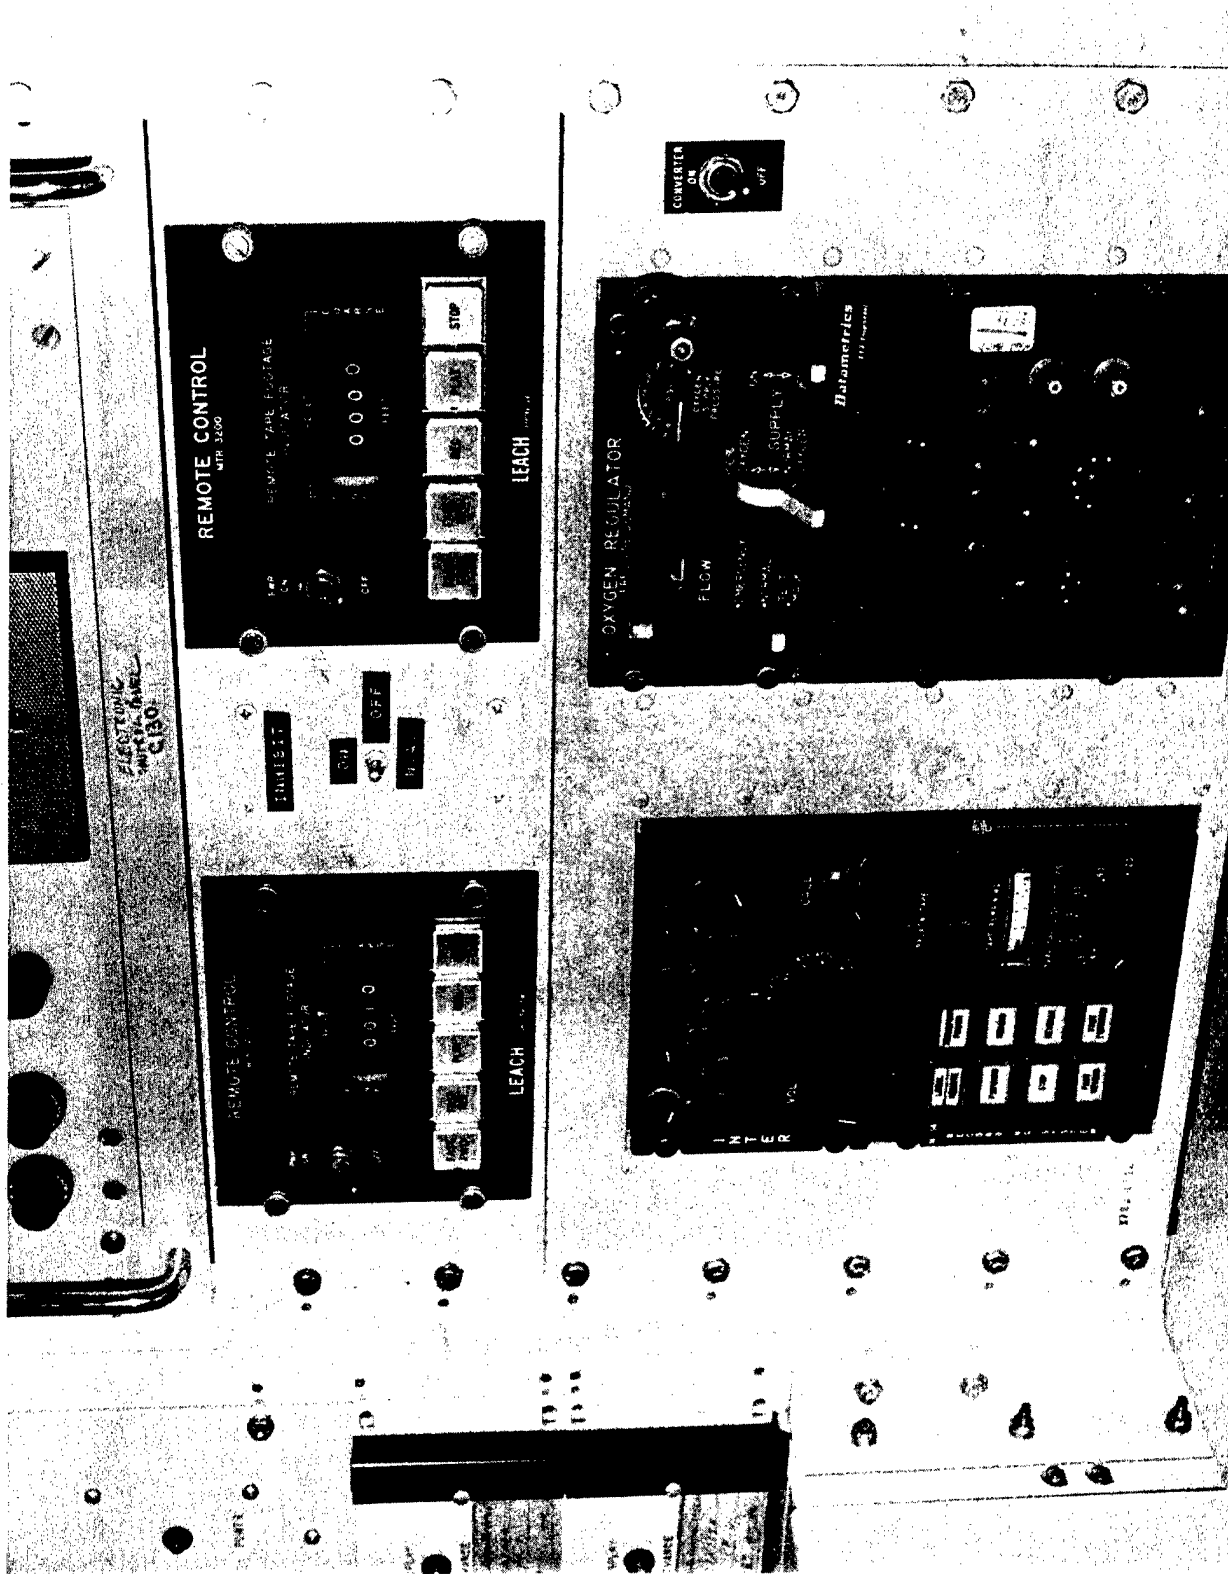
Figure 10. Remote Control Panel for Electronics

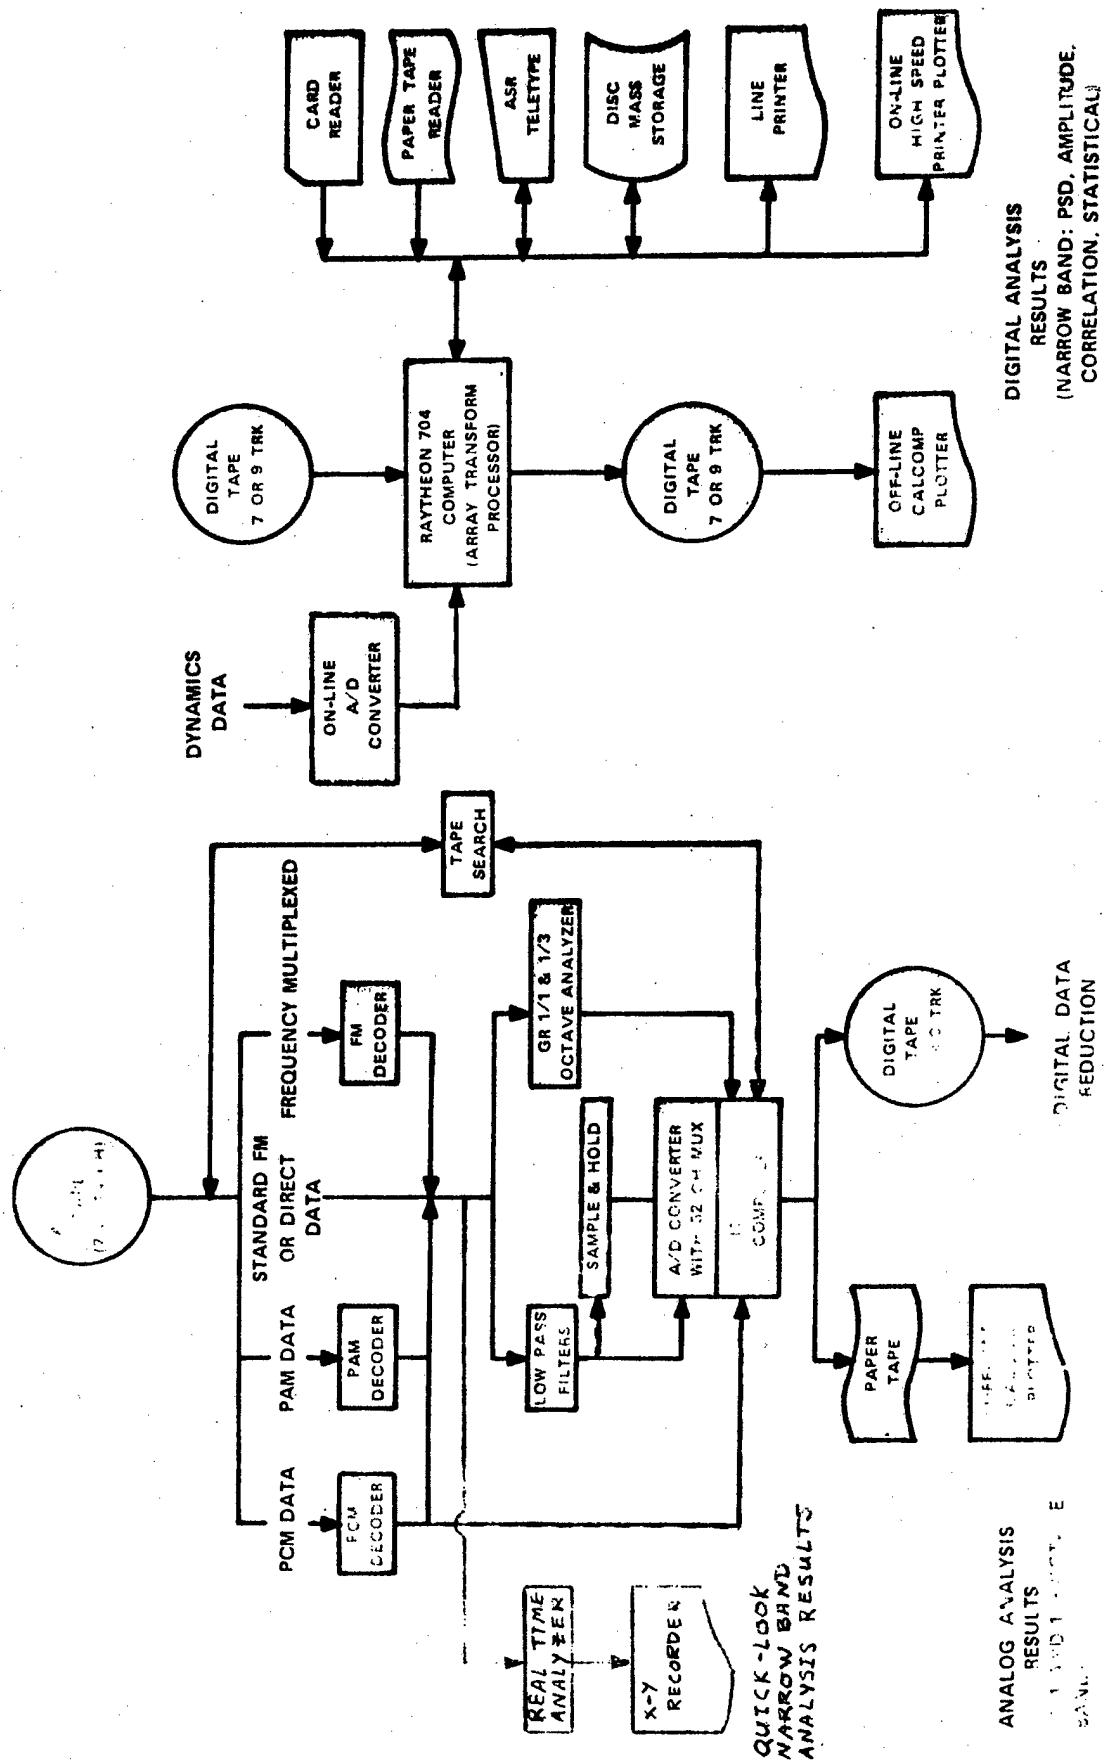
Figure 11. Flow Chart for Data Analysis

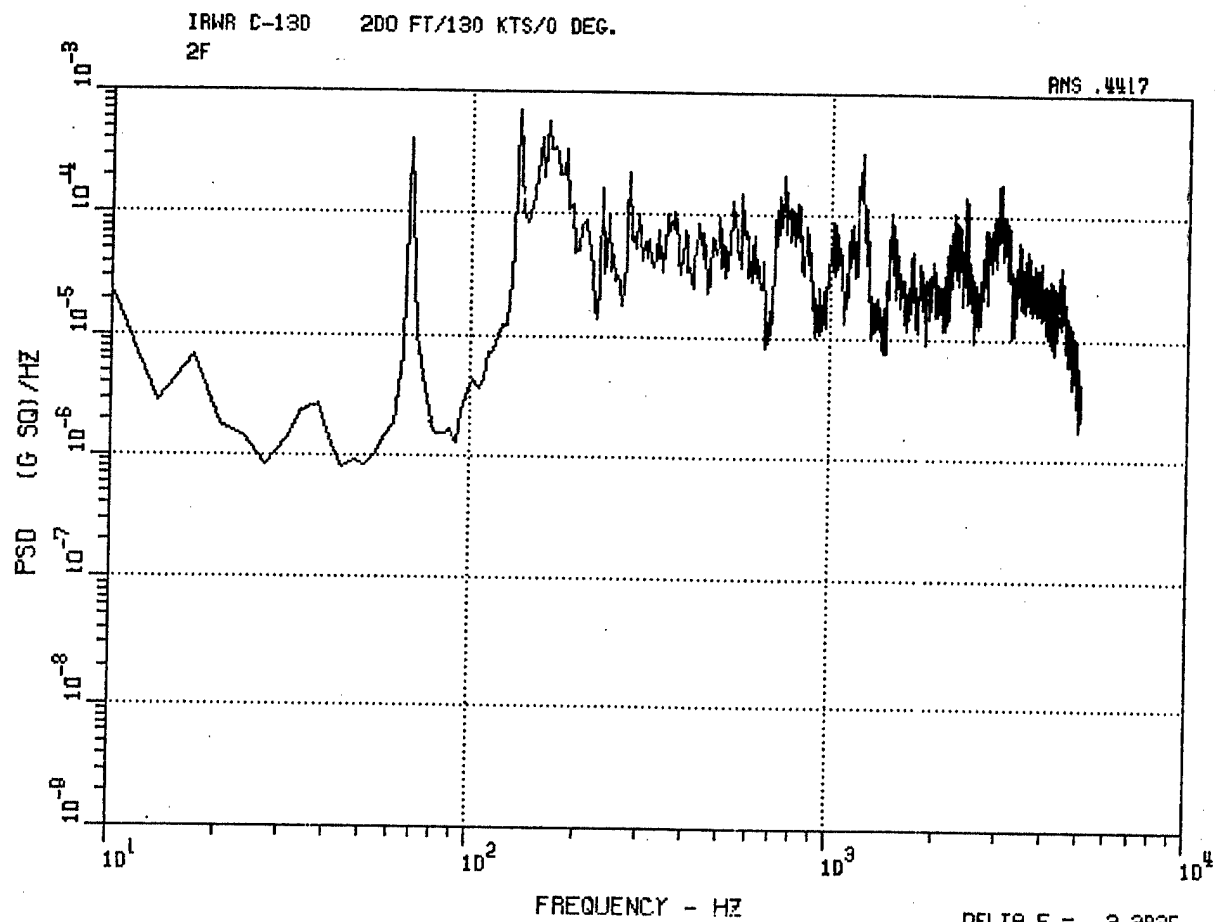
Figure 12. C-130 Fwd Lateral Accelerometer 2F,
200 Ft, 130 Kt, 0 Deg, and 1000 Ft,
130 Kt, 0 Deg.

The C-130 spectra are shown in Figures 12-59. Figures 12-15 show the lateral accelerometer 2F on the forward left AAR-43 for the six flight conditions and for the no-signal condition. This last condition is with instrument power on but with the aircraft engines turned off. It gives a measure of the noise in the instrumentation system. Of particular concern is the 400-Hz electrical supply frequency, which may sometimes be seen in the vibration data. Each of the data plots in this report should be compared with the corresponding no-signal record to determine the validity of individual spectral lines.

The lateral vibration of accelerometer 2F during the low-speed flight conditions (130 Kts) has a very low spectral density below 50 Hz. At 68 Hz there is a major peak corresponding to a propeller blade-passage frequency of 4100 rpm. Above 200 Hz, the spectrum is essentially flat at $10^{-4} \text{ g}^2/\text{Hz}$. For the higher speed flight (250 Kts), the entire spectrum is raised an order of

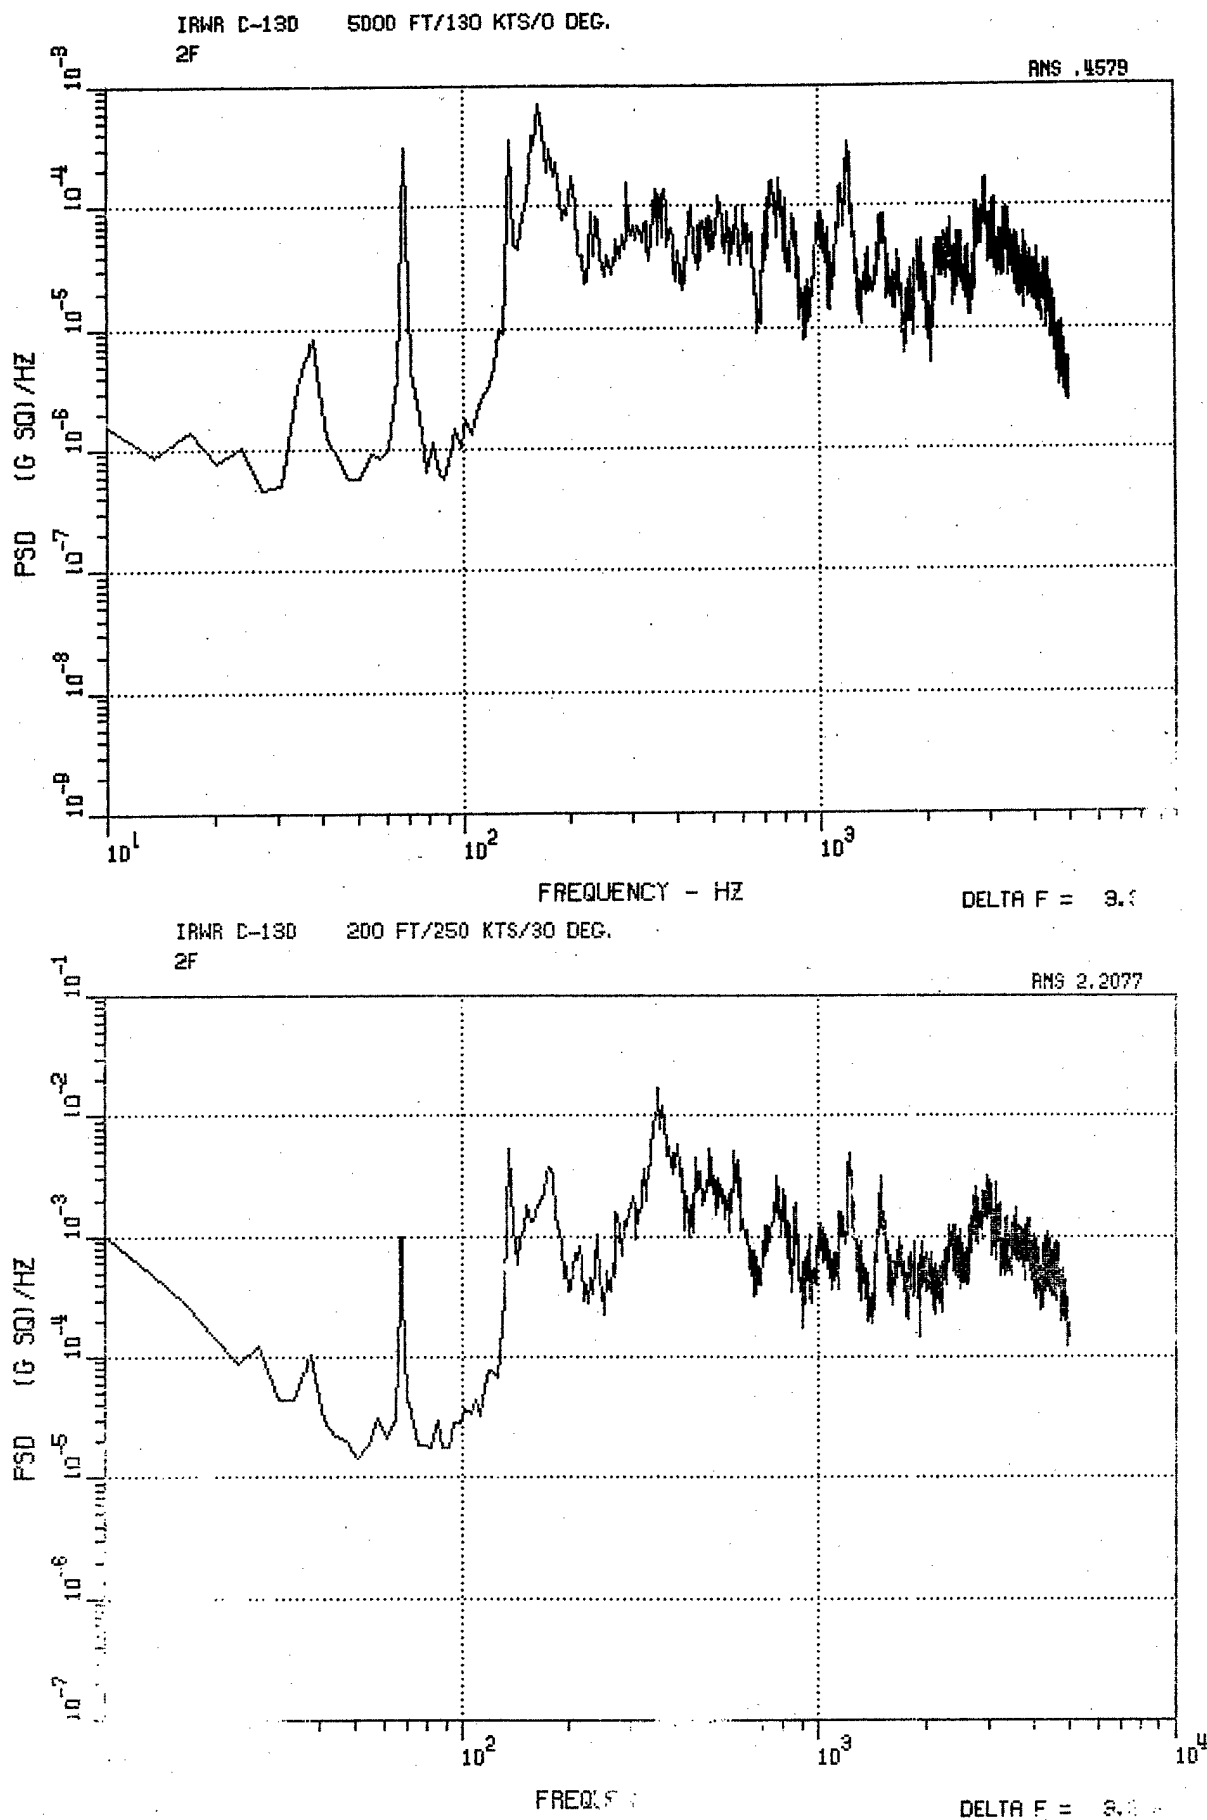
Figure 13. C-130 Fwd Lateral Accelerometer 2F, 5000 Ft, 130 Kt, 0 Deg, and 200 Ft, 250 Kt, 30 Deg.

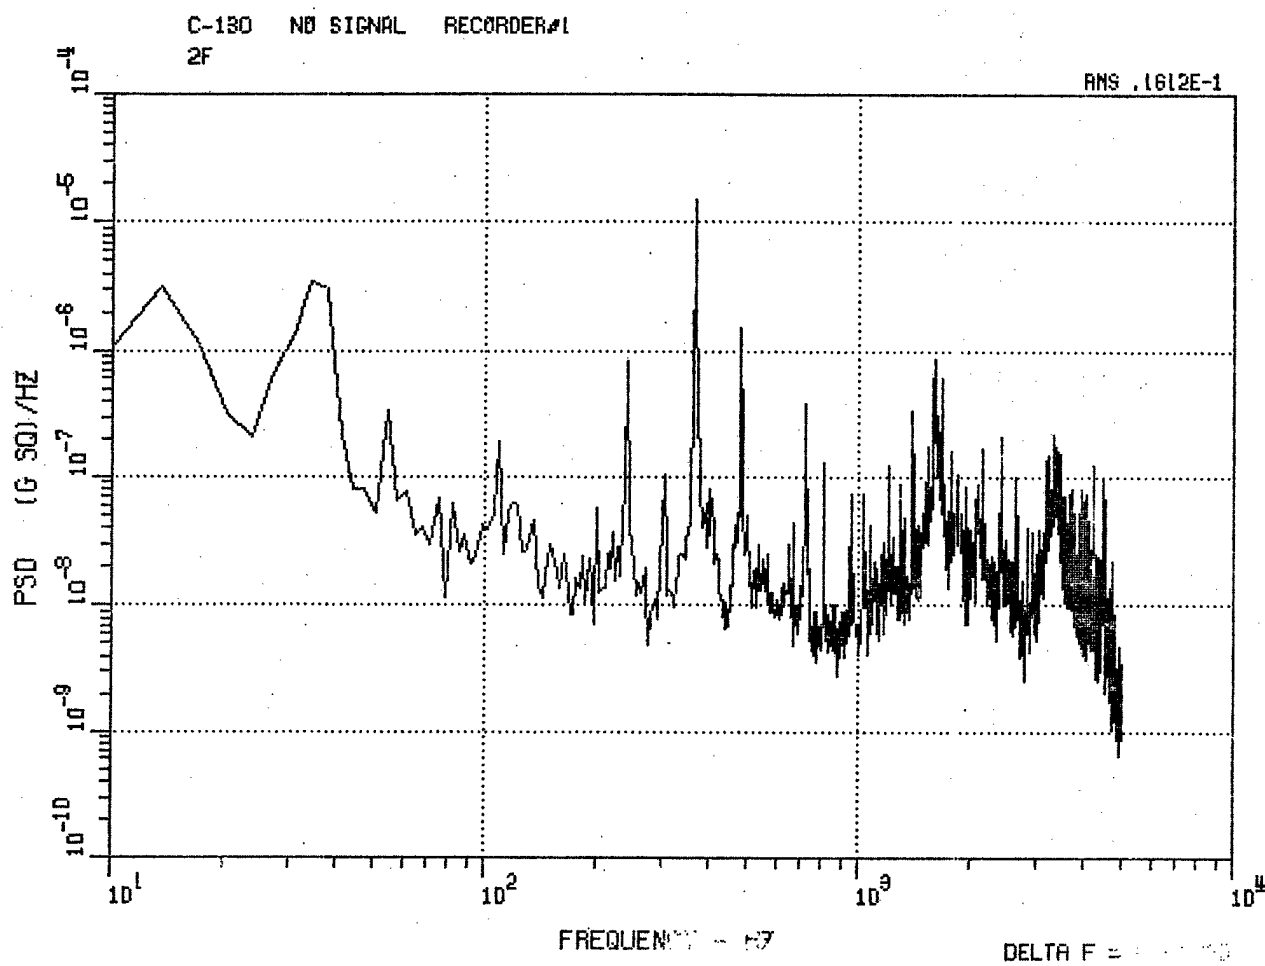
Figure 15. C-130 Fwd Lateral Accelerometer 2F,
No-Signal Record.
